DEPARTMENT OF TRANSPORTATION

Quality Assurance and Source Inspection

Contract #: 04-0120F4Cty: SF/ALA Rte: 80 PM: 13.2/13.9File #: 69.28**WELDING INSPECTION REPORT****Resident Engineer:**Siegenthaler, Peter**Address:** 333 Burma Road**City:** Oakland, CA 94607**Report No:** WIR-018288**Date Inspected:** 26-Nov-2010**Project Name:** SAS Superstructure**OSM Arrival Time:** 645**Prime Contractor:** American Bridge/Fluor Enterprises, a JV**OSM Departure Time:** 1845**Contractor:** Zhenhua Port Machinery Company, Ltd (ZPMC), Changxing Island **Location:** Shanghai, China**CWI Name:** Zhu Zhong Hai.**CWI Present:** Yes No**Inspected CWI report:** Yes No N/A**Rod Oven in Use:** Yes No N/A**Electrode to specification:** Yes No N/A**Weld Procedures Followed:** Yes No N/A**Qualified Welders:** Yes No N/A**Verified Joint Fit-up:** Yes No N/A**Approved Drawings:** Yes No N/A**Approved WPS:** Yes No N/A**Delayed / Cancelled:** Yes No N/A**Bridge No:** 34-0006**Component:** Orthotropic Box Girder(OBG)**Summary of Items Observed:**

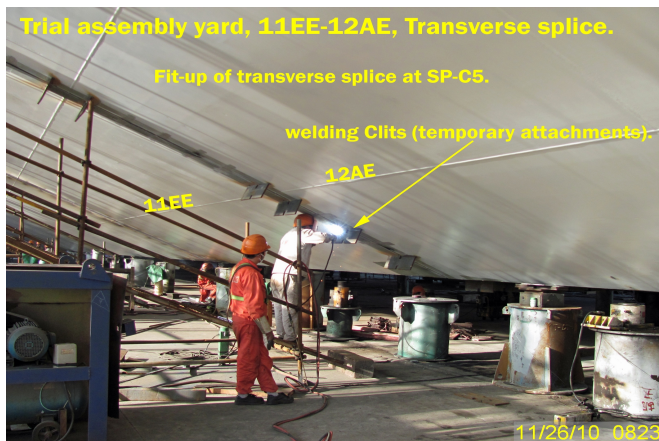
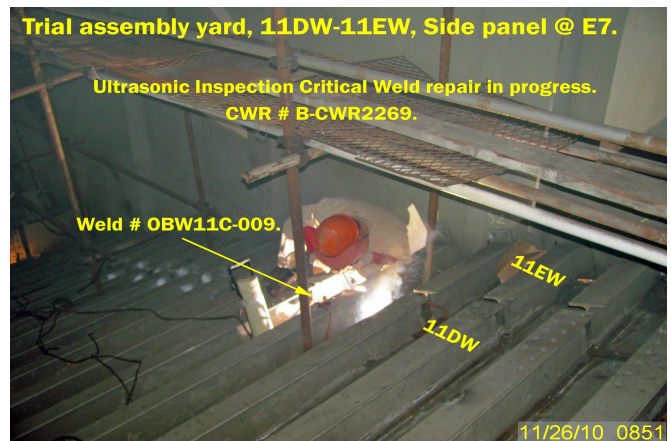
During Random Visual in process Inspection, this QA inspector observed fit-up of transverse splice at intersection of OBG segment 11EE-11AE. Welder observed welding Clits (temporary attachments) using Shielded metal arc welding (SMAW). Welder is identified as 041713; ZPMC Quality Control Inspector (QC) is identified as An Qing Xiang. The welding variables recorded by Quality Control Inspector (QC) appeared to comply with the Applicable WPS: WPS-B-T-2114. The attached photographs provide additional detail.

SMAW Critical Repair welding (Ultrasonic Inspection repair per ZPMC UT-report # UT-11W-077R2) of weld joint OBW11C-009 (CWR # B-CWR2269); located at Trial assembly yard. Welder is identified as 046704; ZPMC Quality Control Inspector (QC) is identified as Zhu Zhong Hai. The welding variables recorded by Quality Control Inspector (QC) appeared to comply with the Applicable WPS: WPS-345-SMAW-3G(3F)-FCM-REPAIR-1. The attached photographs provide additional detail.

SMAW Repair welding (Ultrasonic Inspection repair per ZPMC UT-report # UT-11W-079) of weld joint SEG071A-044 (WRR # B-WR17735); located at Trial assembly yard. Welder is identified as 040611; ZPMC Quality Control Inspector (QC) is identified as Zhu Zhong Hai. The welding variables recorded by Quality Control

Unless otherwise noted, all work observed on this date appeared to generally comply with applicable contract documents.
